# Naval Surface Warfare Center Carderock Division

NSWCCD-TR-61—97/10

Survivability, Structures, and Materials Directorate  
Technical Report

## SEM Stereo-Section Fractography Observations

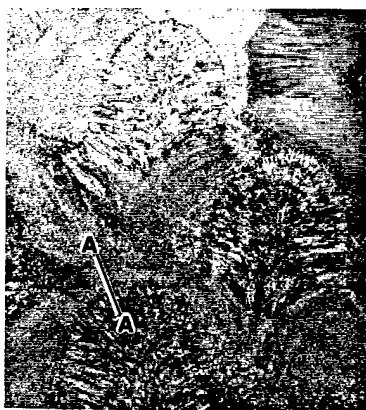
Figure 8a illustrates the weld bead microstructure of specimen G XK 62. The microstructure surrounding the fusion line of one bead (A-A in Figure 8a) has been magnified in Figure 8b. In this picture, the FGHAZ, CGHAZ, fusion line, and the edge of the CCZ are evident. It is important to note the similarity between the CGHAZ and the edge of the CCZ adjacent to the fusion line: both contain allotriomorphic ferrite along the prior austenite grain

Figure 8a: The weld bead structure of specimen GXK 62.

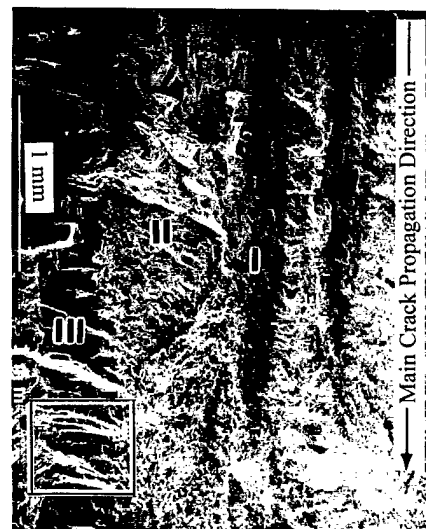
Figure 13a

Figure 13a: A conventional SEM fractograph of specimen SIP-26A showing three distinguishable features.

The SSF technique was also applied to study the cracking behavior of a Ti6Al-4V forging. This material was tested in 3.5% NaCl at room temperature under constant amplitude,  $R=0.1$  loading. The fatigue crack growth rate (FCGR) behavior was highly nonuniform and exhibited sporadic crack growth acceleration and deceleration, especially between  $10 \text{ MPa}\sqrt{\text{m}} < \Delta K < 20 \text{ MPa}\sqrt{\text{m}}$  (Figure 12). Fractographic observation revealed three distinct features on the fatigue surface which contribute to this behavior (Figure 13a): (I) coplanar faceted regions; (II) brittle, randomly-oriented faceted regions; and (III) peculiar transverse regions featuring crystallographic facets and out-of-plane steps or jogs. An enlargement of one of these areas (Figure 13b) illustrates one of the peculiar surface feature III regions.

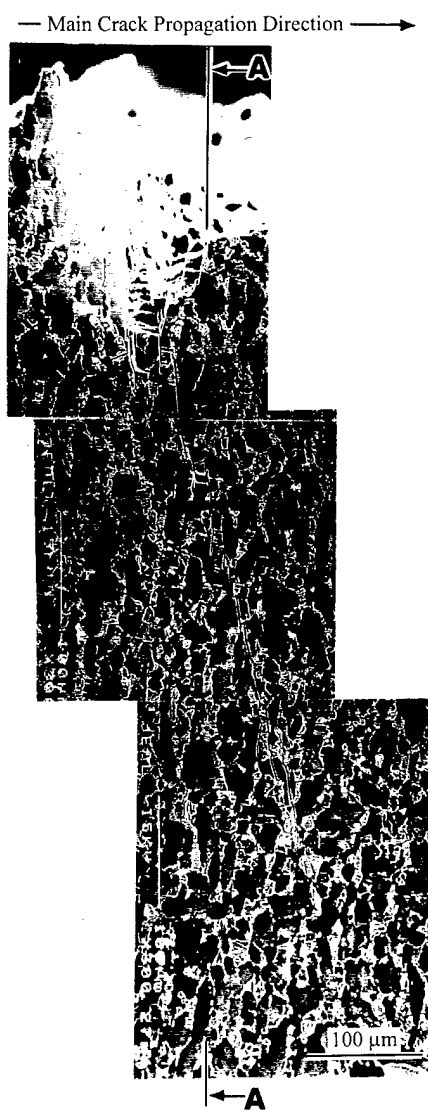
The SSF technique was again utilized to examine the usual transverse section (Figure 1) through a feature III region. These sections are revealed in Figures 14a and 14b and the acuity of these ledges becomes apparent; each is on the order of 100 - 200  $\mu\text{m}$  out of the fracture plane. Closer examination of one of the troughs reveals extensive out-of-plane cracking that follows elongated  $\alpha$  grains. A second SSF section was made perpendicular to the section in Figure 14b (section A-A) near the trough illustrated in this figure. The transverse cracking path is now clearly shown to propagate along elongated  $\alpha$  grains with a preferred orientation (Figure 14c). An enlargement of the trough (boxed area in Figure 14c) illustrates the coplanar nature of this cracking as shown in Figure 14d. The top-most plane is evident in the bottom portion of Figure 14d and is actually the polished and etched microstructure of section A-A (Figure 14b). The layers below this plane are the fracture surfaces of the secondary cracks that appear to the left of section A-A (Figure 14b). The correspondence between the crack surfaces and the microstructure is striking and indicates the crystallographic nature of this cracking, the relative weakness of this orientation, and the strong texture within this region.

Figure 14b: An enlargement of the boxed area in 14a showing the long vertical secondary cracks.
